MICROSTRUCTURAL COMPATIBILITY OF AN  
Al-Li-Cu-Mg-Zr ALLOY EXPOSED TO CORROSIVE  
ENVIRONMENTS

T. S. Srivatsan

Materials Modification Inc.  
Falls Church Virginia 22044

FINAL REPORT  
(Period: 15 November 1986 to 15 May 1987)  
Contract No. N60921-86-M-7570  
Department of the Navy  
Naval Surface Weapons Center  
Silver Spring, Maryland 20903

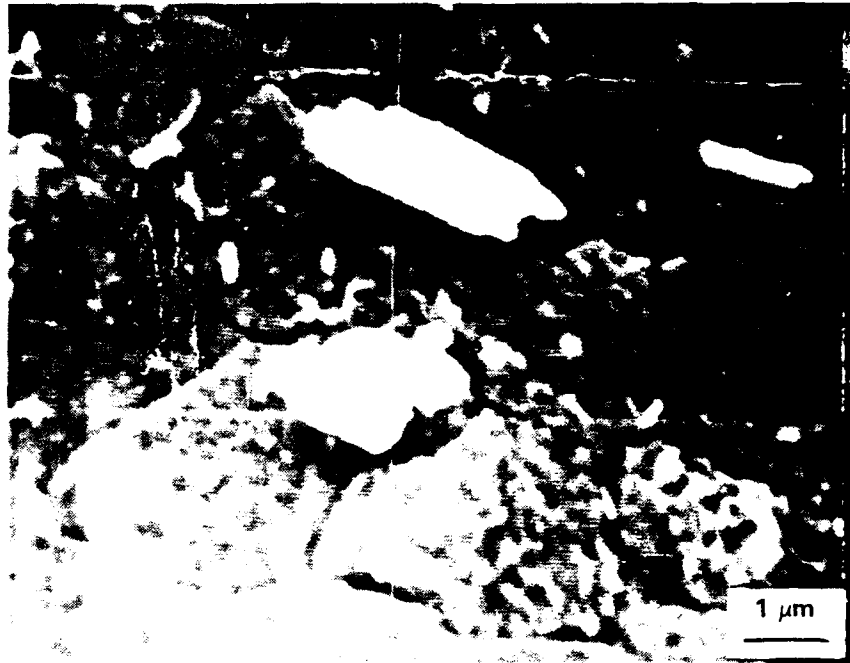
FIGURE 12. SCANNING ELECTRON MICROGRAPH SHOWING MORPHOLOGY OF IRON-RICH INTERMETALLIC ( $\text{Al}_7\text{Cu}_2\text{Fe}$ ) ON BROMINE-ETCHED SURFACE (T851 CONDITION)

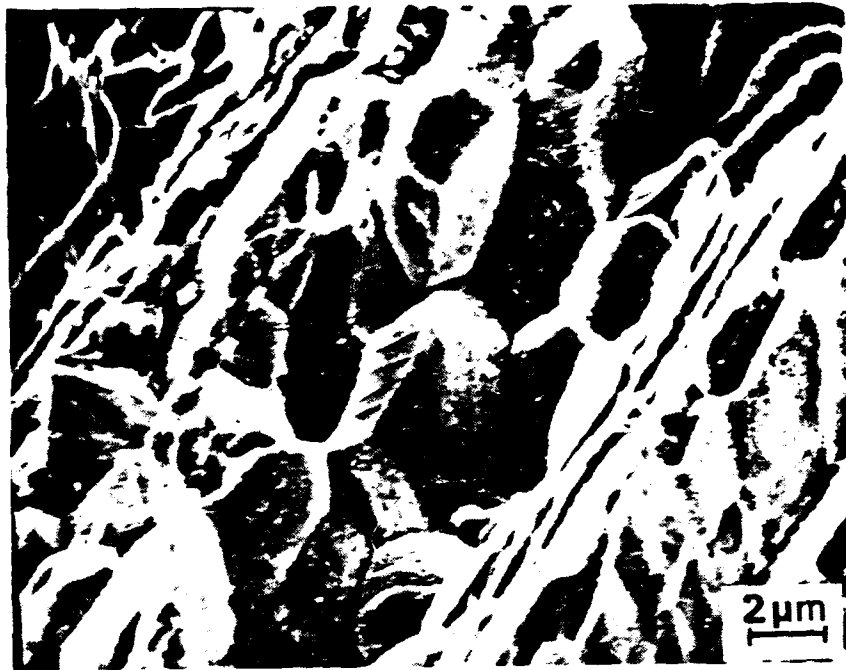
FIGURE 22. (a) FRACTOGRAPH OF RIDGE SHOWING INTERGRANULAR CRACKING ALONG THE SUBGRAIN BOUNDARIES. (b) SCHEMATIC SHOWING INTERGRANULAR CRACKING ALONG SUBGRAINS WITHIN AN UNRECRYSTALLIZED GRAIN
